CALIFORNIA GEOLOGICAL SURVEY FAULT EVALUATION REPORT 265

THE ROSE CANYON FAULT ZONE in the Point Loma and La Jolla 7.5 Minute Quadrangles San Diego County, California

Michael DeFrisco

February 18, 2021

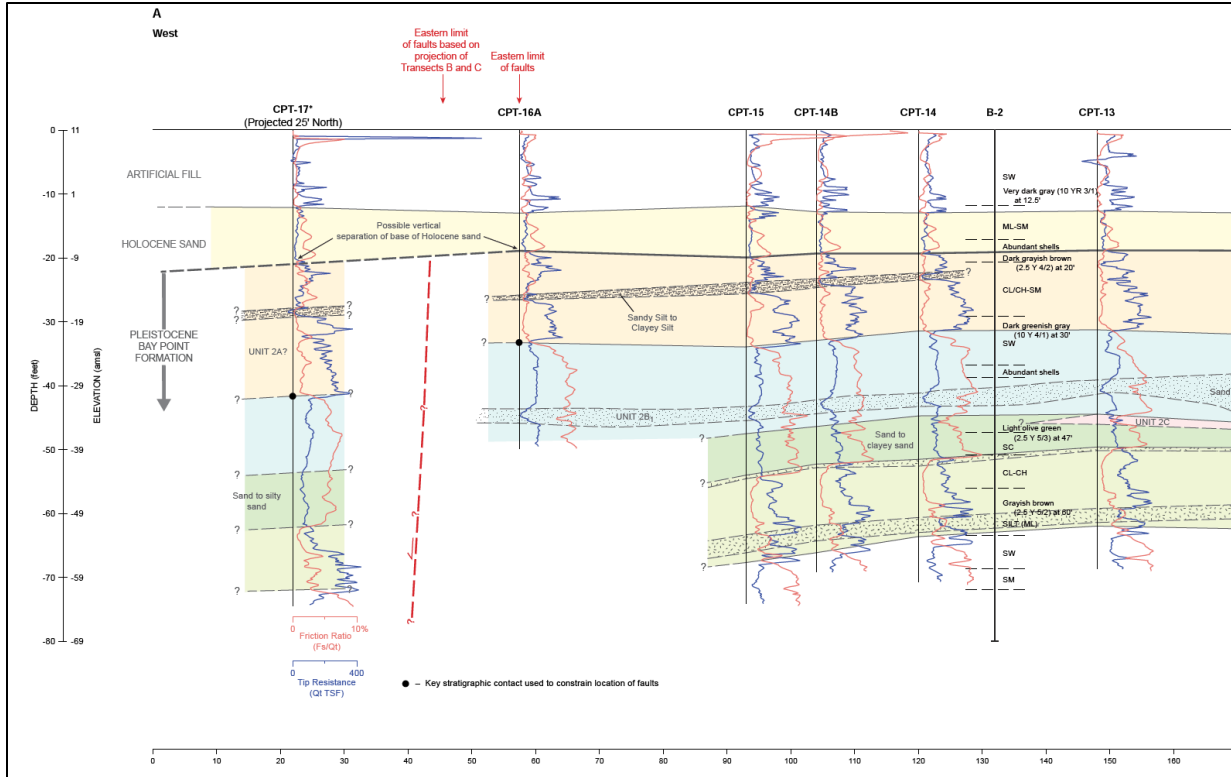
Figure 10. Portion of Geologic Cross Section A-A' by William Lettis & Associates, Inc. (WLA, 2008a) at the Old Police Headquarters (Locality 29). The fault appears to offset the base of the Holocene alluvium by 2 feet. WLA suggested the zone of faulting may be associated with the offshore Coronado Fault to the south and/or the PCH Fault to the north.

- Faults appear to offset uppermost Pleistocene Bay Point Formation in all geologic cross sections and appear to offset the base of Holocene alluvium by two feet in Geologic Section A-A' (Figure 10).
- No unfaulted strata of pre-Holocene age can be used to preclude Holocene slip.
- The Holocene-active Coronado Fault projects onshore near the western margin of the site, and the zone of faulting identified in this study may be associated with the Coronado Fault.

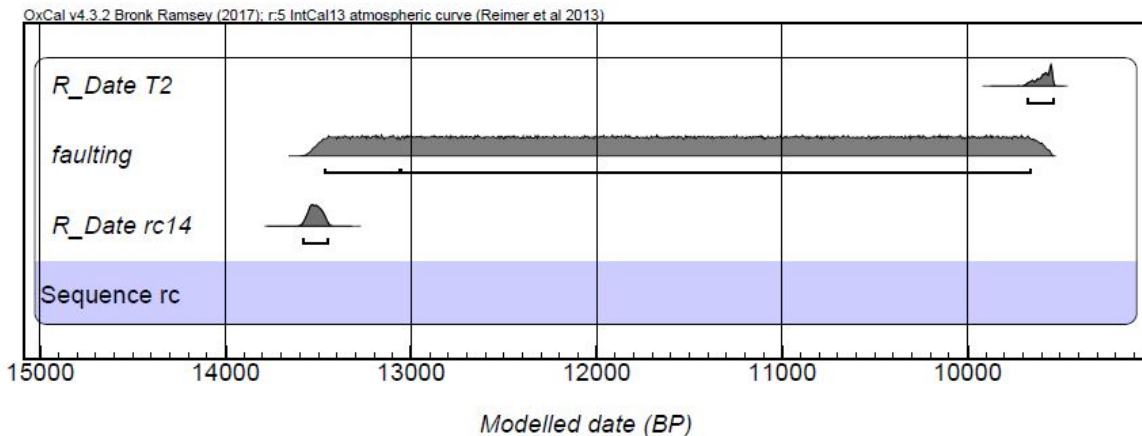
Figure 12. Oxcal chronological model (CGS, this study) of Radiocarbon data collected from Locality 27, Santa Fe Depot Parcel 1, indicating a range of faulting from 10.3 to 13.4 ka for the PCH Fault.

We evaluated the most recent fault activity by updating the radiocarbon analysis with more recent calibration curves (Reimer *et al.*, 2020) and standard Oxcal chronological modeling (Bronk-Ramsey, 1994) (Figure 12). The age of the most recent faulting was constrained the best in trench T2 (Figure 9) and is bracketed between samples RC24 and RC14. This results in a possible age of faulting ranging from 10.3 to 13.4 ka. In trench T3 a similar age can be interpreted. Regardless of which chronologic model is used, the timing of the most recent earthquake at Locality 27 is latest Pleistocene to early Holocene in age and classifies the fault as Holocene-active based on the current definition for an active fault as one which has moved within the last 11,700 years.
