# SMIP90 Seminar Proceedings

## EVALUATION OF LATERAL FORCE PROCEDURES FOR BUILDINGS

Gregory L. Fenves  
Assistant Professor  
Department of Civil Engineering  
University of California at Berkeley

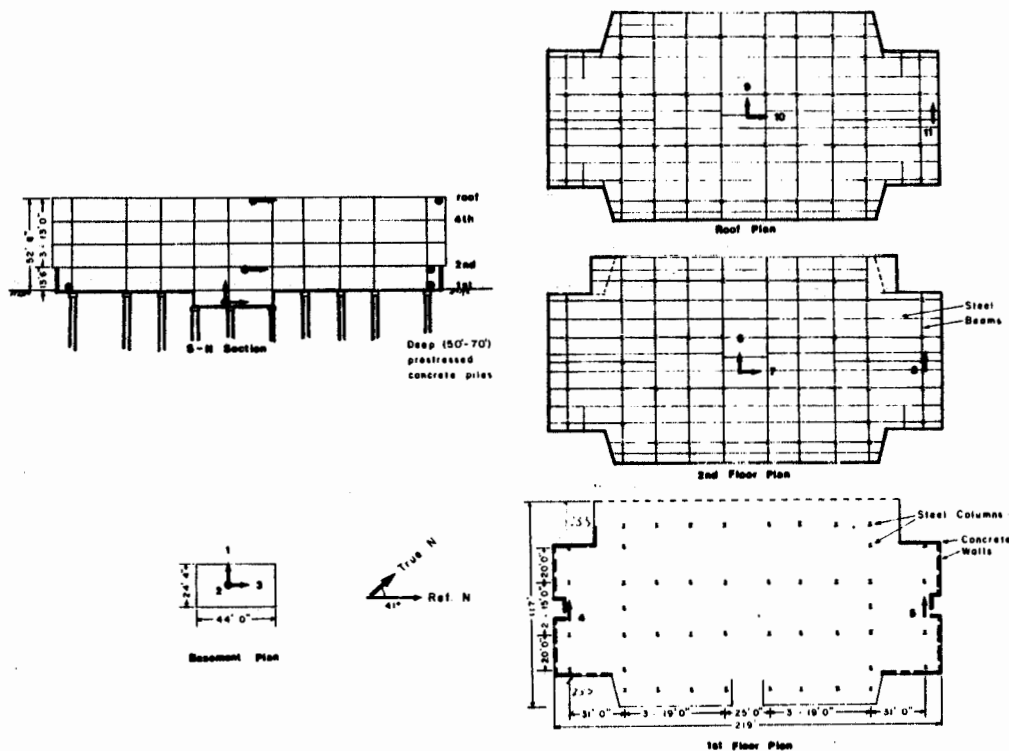
FIGURE 1. Structural Configuration and Instrumentation for Building One - Four Story Hospital [2,4]

The four story medical center is located in South San Francisco. Figure 1 shows the structural configuration of the building. The gravity load system consists of a lightweight concrete slab on metal decking supported by floor beams. The lateral force resisting system is a structural steel moment resisting frame. The foundation for each column consists fifty to seventy foot piles; grade beams connect the pile caps and support an eight inch slab. The building is instrumented with eleven acceleration transducers at the locations shown in Figure 1.

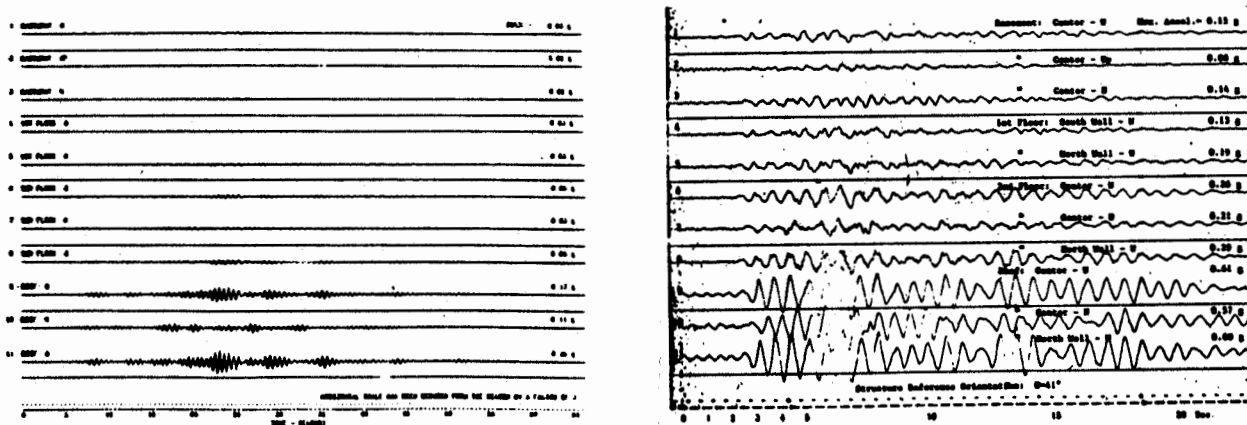
(a) 1984 Morgan Hill Earthquake [4]

(b) 1989 Loma Prieta Earthquake [2]

FIGURE 2. Unprocessed Response Records for Building One - Four Story Hospital

The unprocessed records are shown in Figure 2(a) and the peak total accelerations are listed in Table 1. Figures 3 and 4 show two sets of the transmissibility functions for total acceleration in each direction: (i) between the roof and ground level; and (ii) the second level and ground. The transmissibility functions are the ratio of the Fourier transform of the corrected acceleration records computed over two time windows. The first time window, zero to fifteen seconds, shows the response before the strong response, and the second time window, fifteen to forty seconds contains the strong ground motion and response. The transmissibility functions for frequencies less than one-half Hertz have not been considered in the interpretation.

The unprocessed records from the Loma Prieta earthquake are shown in Figure 2(b) and the peak responses are also listed in Table 1 [2]. The ground motion and building response was significantly greater in Loma Prieta than in Morgan Hill, yet there was no damage to the structural or nonstructural components of the building<sup>1</sup>. The transmissibility functions computed from the processed records for two time windows are shown in Figure 4 for two time windows: (i) zero to nine seconds, and (ii) nine to twenty six seconds. Based

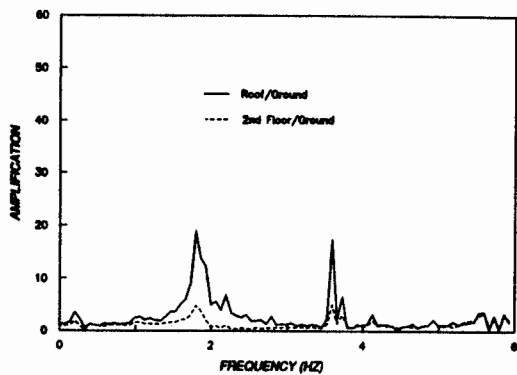
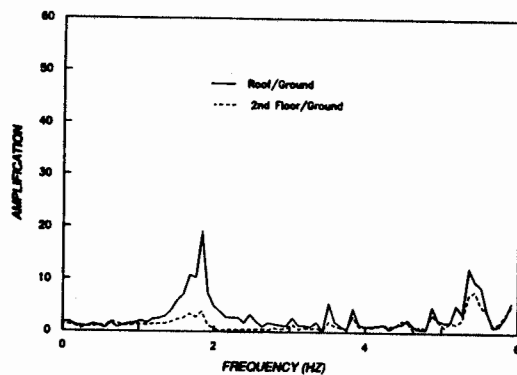
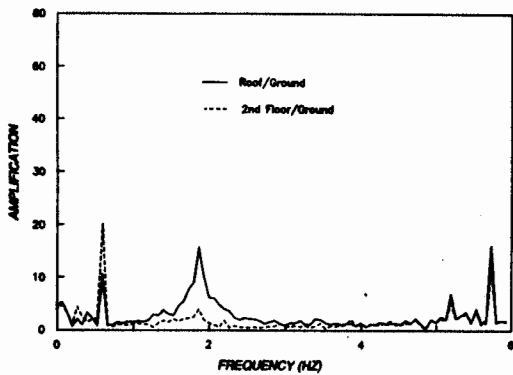
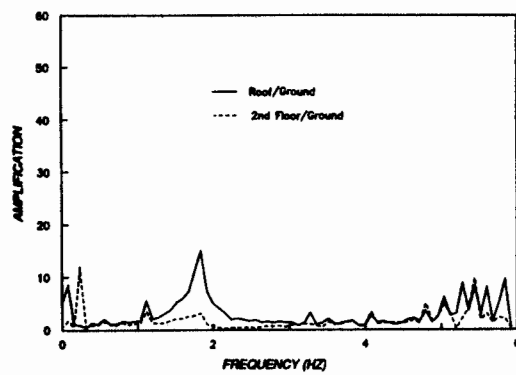
(a) Transverse Direction, 0-15 sec

(b) Transverse Direction, 15-40 sec

(c) Longitudinal Direction, 0-15 sec

(d) Longitudinal Direction, 15-40 sec

FIGURE 3. Transmissibility Functions for Building One - Four Story Hospital for the 1984 Morgan Hill Earthquake

on these functions, the periods are listed in Table 2. The damping was larger than in the Morgan Hill earthquake as can be seen by comparing the peaks of the transmissibility functions between Figures 3 and 4, but the half-power bandwidth method does not give reliable values because of the closely correlated modes. The large amplitude of the response results in significantly longer periods than for the Morgan Hill earthquake, and the  $C_t$  coefficient of 0.036 compares favorably with the code value. The fundamental mode shape in each direction (Figure 6) clearly shows the first floor wall does not resist lateral forces because the shape is typical for the racking mode shape of a frame structure.

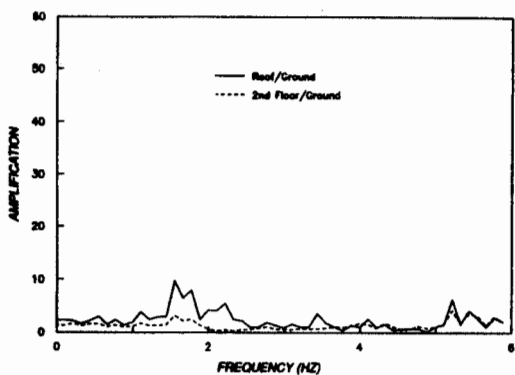
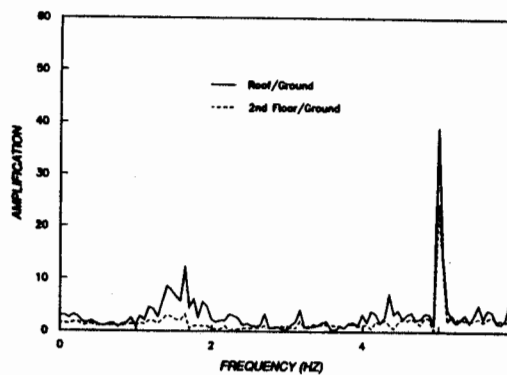
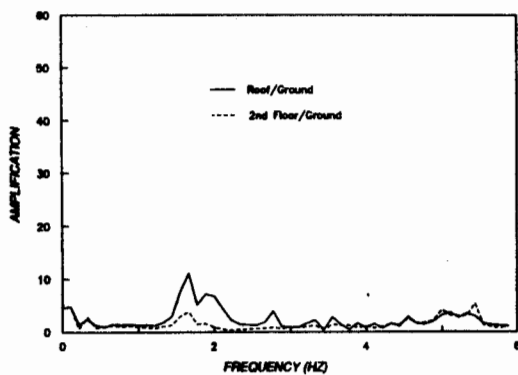
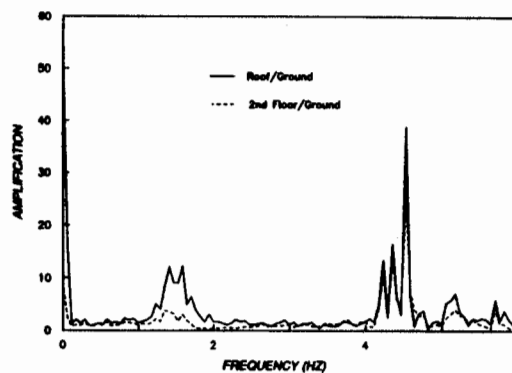
(a) Transverse Direction, 0-9 sec

(b) Transverse Direction, 9-26 sec

(c) Longitudinal Direction, 0-9 sec

(d) Longitudinal Direction, 9-26 sec

FIGURE 4. Transmissibility Functions for Building One - Four Story Hospital for the 1989 Loma Prieta Earthquake

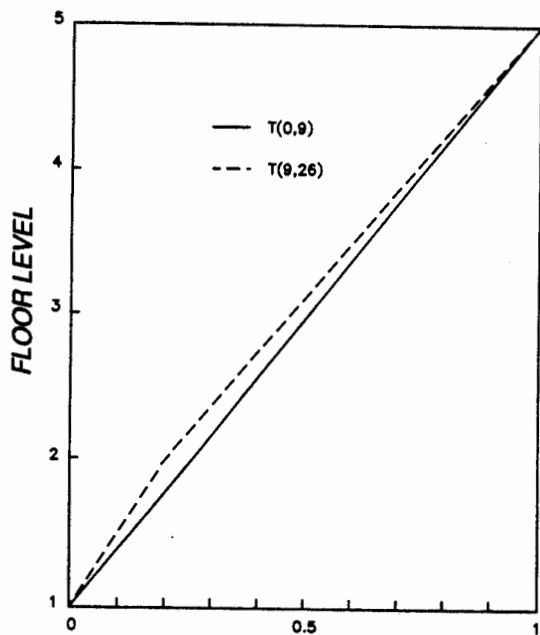
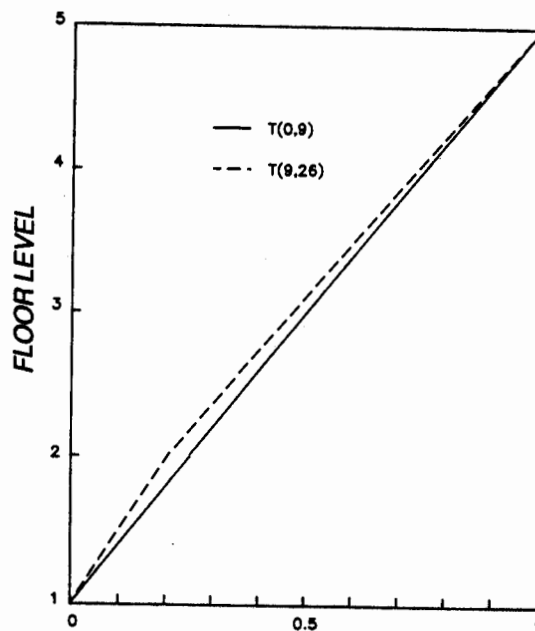
(a) Transverse Direction

(b) Longitudinal Direction

FIGURE 5. Lower Vibration Mode Shapes for Building One - Four Story Hospital for the 1984 Morgan Hill Earthquake

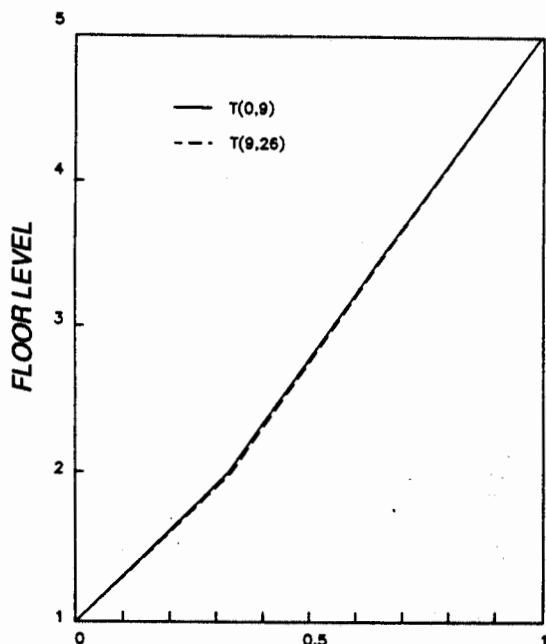
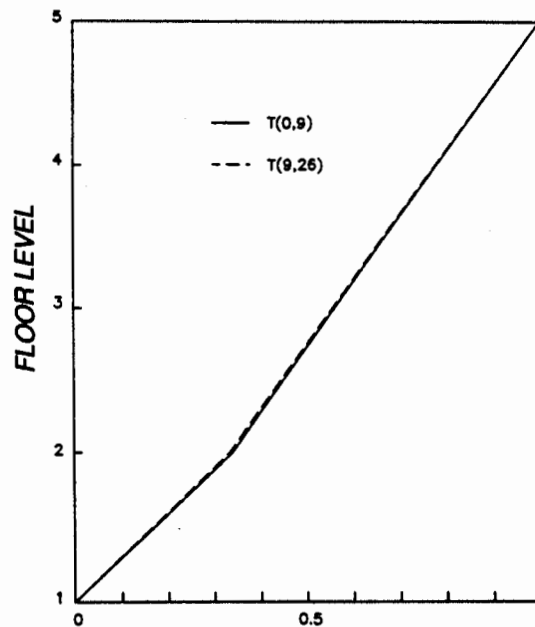
(a) Transverse Direction

(b) Longitudinal Direction

FIGURE 6. Lower Vibration Mode Shapes for Building One - Four Story Hospital for the 1989 Loma Prieta Earthquake

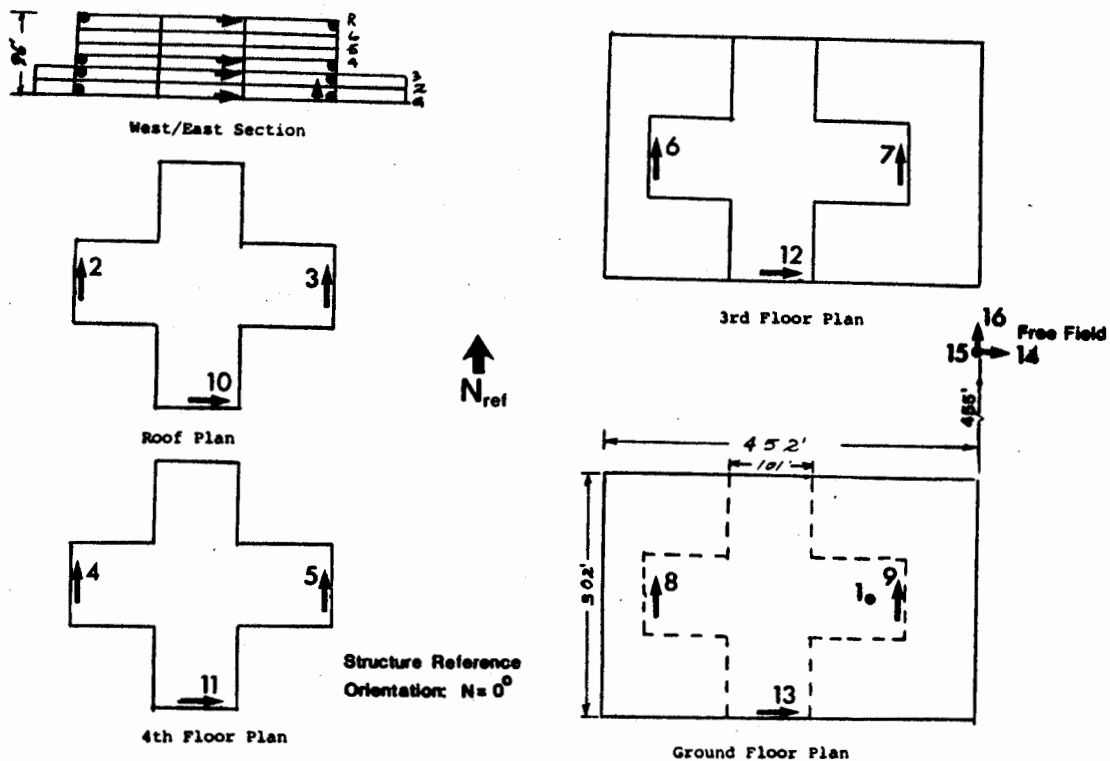
FIGURE 7. Structural Configuration and Instrumentation for Building Two - Six Story Hospital [3]

This six story hospital in Sylmar has a rectangular plan in the lower two floors and a cruciform plan in the upper four floors (Figure 7). The floor system is concrete slab on metal decks. The lateral force resisting system consists of concrete shear walls in the lower two stories and steel shear walls in the upper four stories. The structure has both plan and vertical irregularities according to the code definitions.

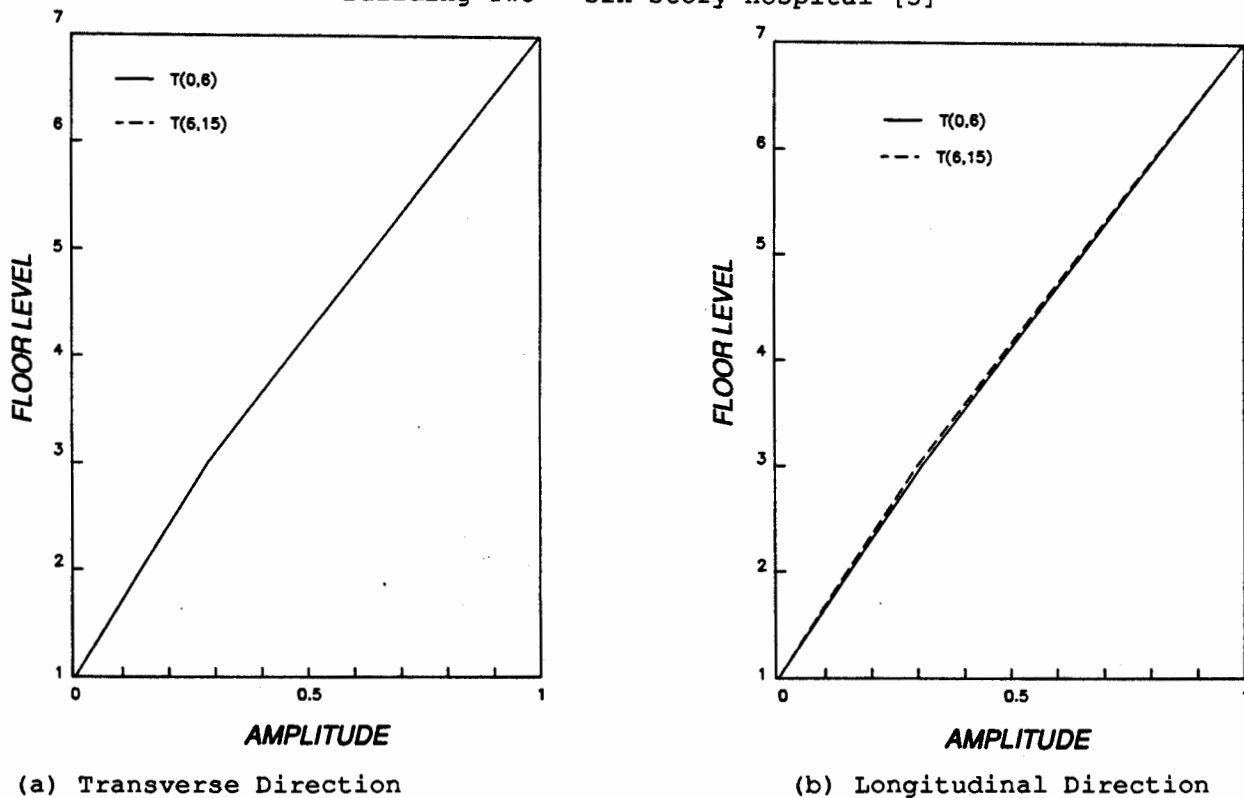
FIGURE 8. Lower Vibration Mode Shapes for Building Two - Six Story Hospital for the 1987 Whittier Earthquake

The building was instrumented with sixteen acceleration transducers in the 1987 Whittier earthquake (although one malfunctioned) [3]. The large stiffness of the lower two floor is clear from the mode shapes obtained from the transmissibility functions (Figure 8), where the relative amplitude of the vibration mode between the third floor and roof is larger than between the base and the third floor.
