# The Effect of the 2011 Tohoku Tsunami on the California Coastline

## ABSTRACT

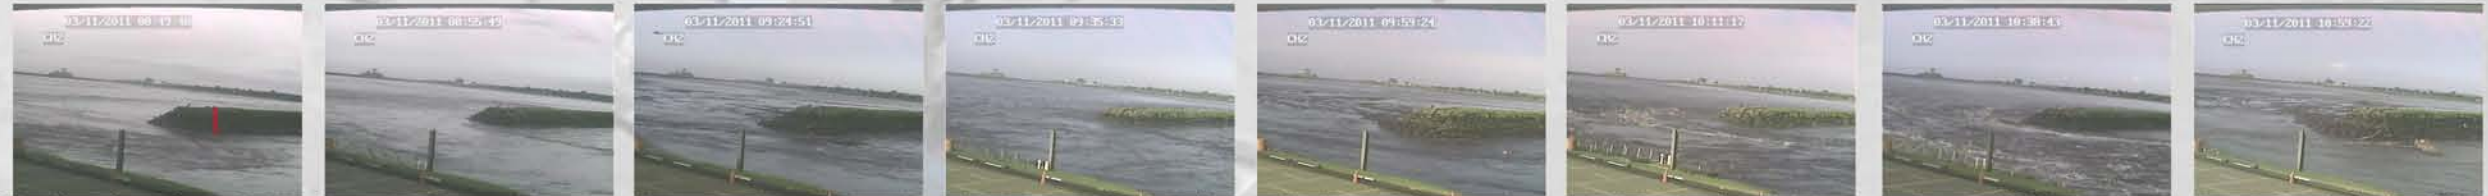
Selected frames from the Crescent City Harbor Security camera. The view is to the north across their entrance to the small boat basin where all of the damage occurred. The height of the exposed breakwater in the first frame is three meters (red bar). In these frames, the highest water is shown in the 9:35 AM photo, when the actual water height was 8.5 feet above MLLW. Note the displaced dock in the last frame. The maximum current velocity at this location was 8.2 knots.

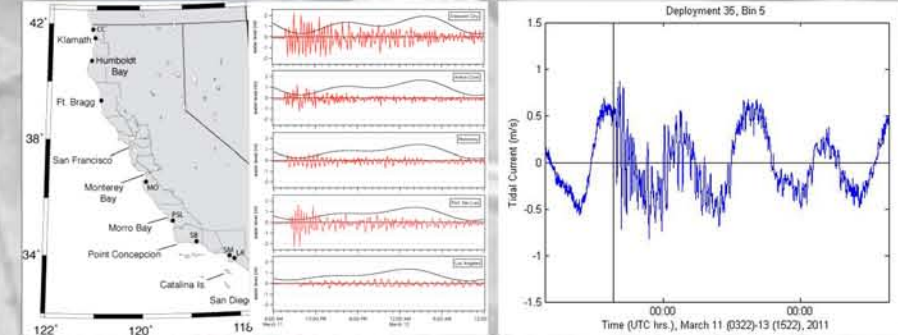
Left: Water level recordings along the California coast. Red signals are the detided tsunami for the first day of the event. Black shows the predicted tide. Damage was minimized in California because the largest amplitude surges coincided with low tide. Right: Current velocities recorded inside Humboldt Bay on a Nortek Aquadopp Acoustic Doppler 2D current profiler. Vertical line is the onset of the tsunami. All of the damage on the California coast was caused by strong currents. Harbors with a small or elongate narrow opening, or within river valleys were particularly vulnerable. Damage was concentrated near the entrance or where there are restrictions inside, or within the entrance along the direction of flow. The most vulnerable docks were those with a large number of boats tied to them, or with boats with large keels, perpendicular to the normal flow direction.

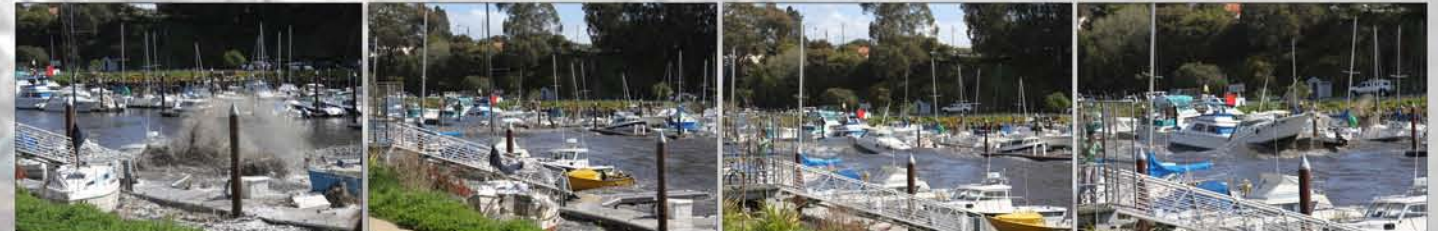
Santa Cruz Harbor. All of the damage was caused by a series of surges in the channel. An estimated \$26.4 million in damages were reported in Santa Cruz, the largest losses in the state. Since the tsunami, businesses estimate continuing losses in revenue of \$59,000 at day. Linda Azevedo photographs.
